ANNUAL REPORT FOR 2000

Bridge Maintenance Mitigation Site New Hanover County Project No. 8.2250109 TIP No. U-92 WM

Prepared By:
Natural Systems Unit & Roadside Environmental Unit
North Carolina Department of Transportation
December 2000

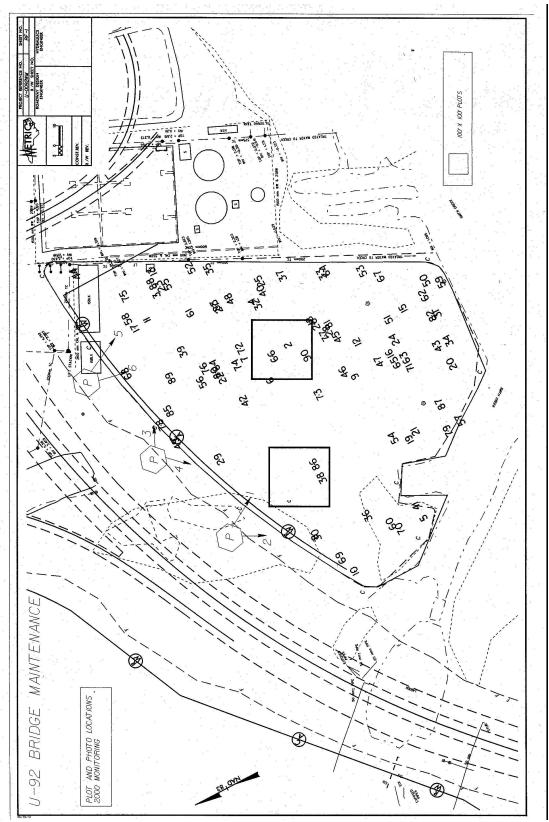
Figure 4: Vegetation Plot and Photo Locations

Bald cypress was planted on 20' centers throughout the approximately 5.7 acre site. Two 100' x 100' plots were established in the planting area (Figure 4). The vegetation monitoring of the planted area revealed **41** bald cypress trees counted within the plots. There is no success criterion to meet on this portion of the project.
